Capela Xeral das Ánimas, Santiago de Compostela

Main building's characteristics and actual systems provided

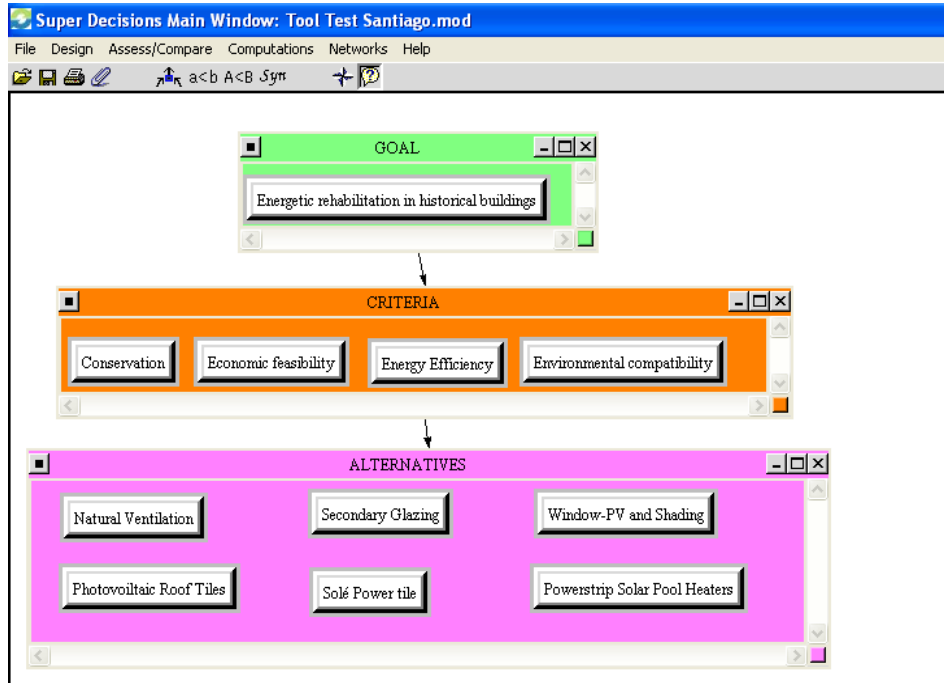
Evaluation model

Starting from the point that main objective (goal) for which the tool has been developed, is to evaluate different solutions for the energetic rehabilitation in historical buildings and following criteria established by ITABC, different alternatives have been chosen after a study of the building and the analysis of possible interventions.

Once established the hierarchical structure of the criteria, each selected alternative was compared for each criterion.

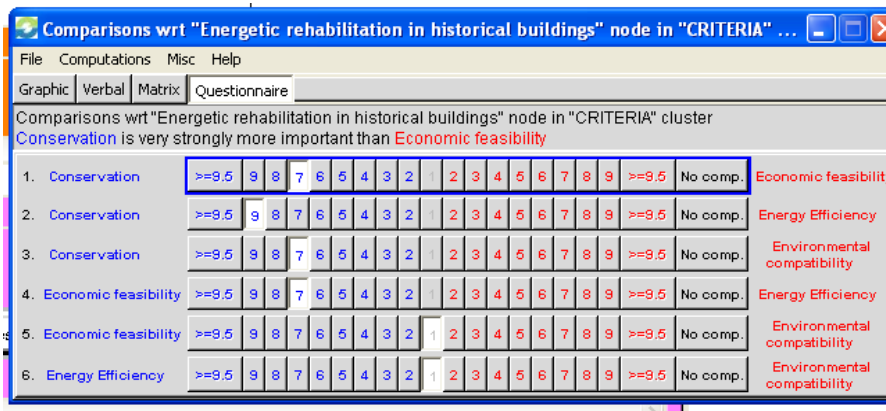
Comparisons wrt "Energetic rehabilitation in historical buildings" node in "CRITERIA" cluster

Conservation is very strongly more important than Economic feasibility

First step was assigning priorities to the criteria established. The expert team gave more importance to the conservation criterion respect all the other criteria. Santiago is declared as a World Heritage Site and conservation is the fundamental for the preservation its historical city. Expert team also judged that environment compatibility is equally important as economic feasibility and energy efficiency and that economic feasibility is more important than energy efficiency. The judgement is in line with the Consorcio philosophy which is based on small conservation interventions aimed at meeting a large part of citizens’ requests in order to motivate people living in the historical centre.

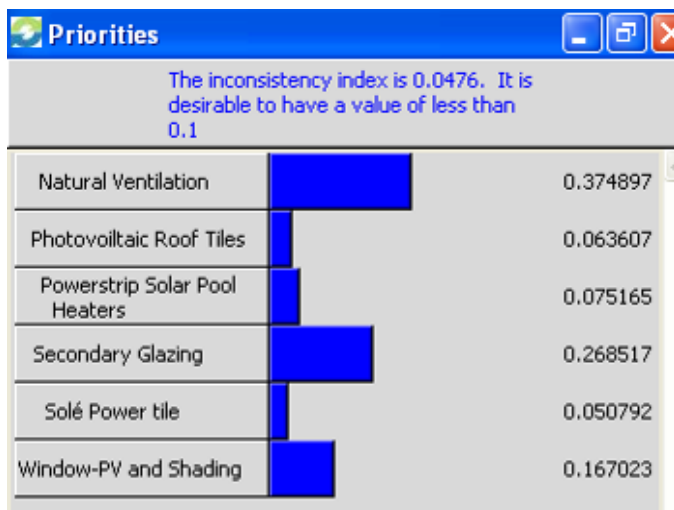
2. Economic feasibility

By assessing economic budgetary feasibility costs, amortizable time and low consumption have been taken into account. Also in this case, technologies that don't present a high initial inversion have been awarded. In the case study of Santiago a roof intervention will suppose an expensive capital expenditure which will give benefits in a large period.
