## **Energy Efficiency in Historic Buildings, the case study of the National Theatre of Rhodes, Greece and of the Zena Castle, Italy**

***Maria Kikira<sup>a</sup>, Elena Gigliarelli<sup>b</sup>***

A study of an example of historic excellence such as the National Theatre of Rhodes in Greece and the Castle of Zena near Piacenza in Italy is presented. The energy audit and energy efficiency study reveal the quality of the design and construction of such buildings and underline the prospective of envelope and cooling system improvement, while revitalising their use and restoring their architectural characteristics.

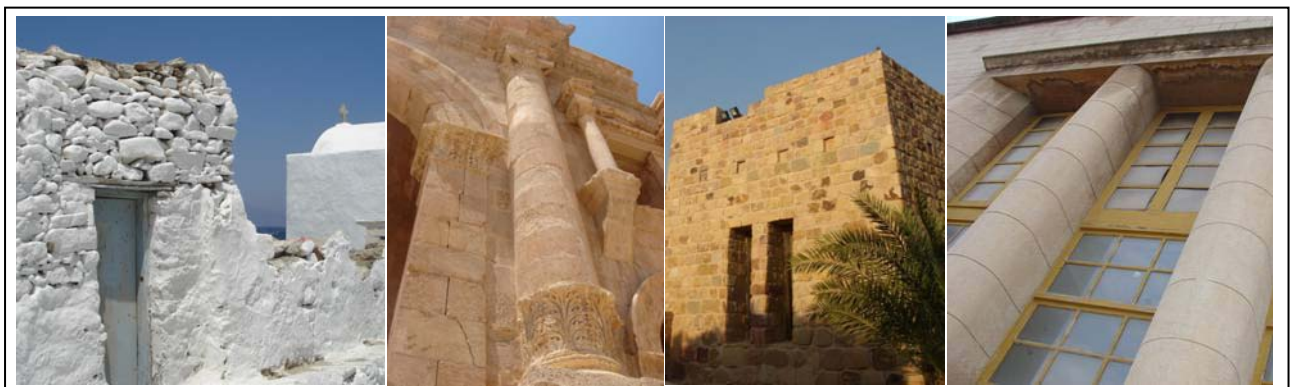
**Fig. 1: Photos...thermal mass, colours, openings, dignity of historic buildings. (Source: [4])**

- Architectural and historical excellence.
- Significantly high heights / large volumes (+) *efficient cooling performance*, (-) *high heating demand*.
- Increased thermal mass, increased wall thickness, solid walls with no insulation (+) *control of internal temperatures, smooth temperature fluctuation, qualitative envelope performance*.

- Controlled and limited openings (window to wall ration often less than 20%)...while contemporary design move towards light and total transparency (+) *control sun and light* (-) *limit passive heating potential*.

- Recessed windows and openings (+) *Self-shading, moderate overheating*.
- External overhangs, patio, terraces, trees, internal courtyards, roof openings, solar and ventilation chimneys (+) *Surrounding space cooling and ventilation, improved microclimate*.

- Earth and light colours (+) *Environmental and climate deference*.
- Natural lighting and ventilation (+) *Human satisfaction and expectation success standards*.

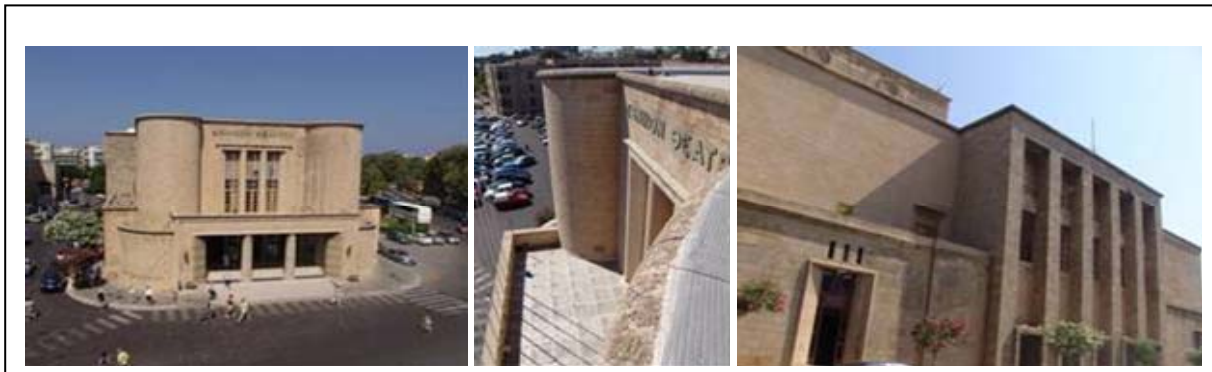
**Fig. 3: External images of the building – Left: East façade, main entrance – Right: South façade. (Source: Division of Preservation of the Medieval City of the Municipality of Rhodes)**

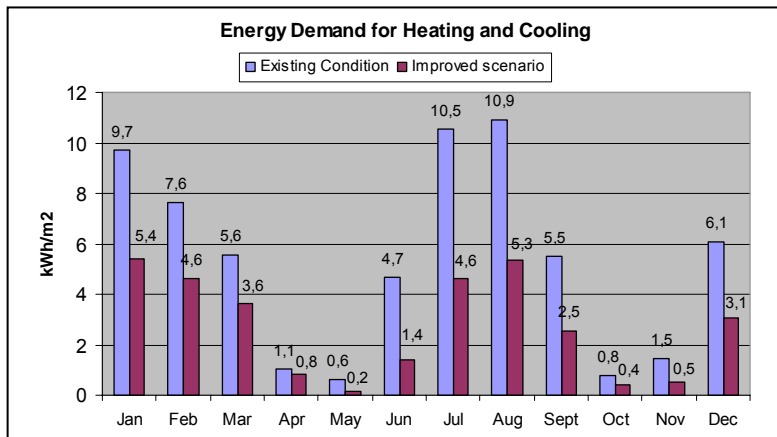
**Fig. 8: Building total energy demand for heating and cooling before and after the proposed interventions (Source: [6])**

The graph below summarizes the results in energy demand for heating and cooling before and after the proposed interventions. It is evident that most significant impact to the building's energy performance is recorded in the peak winter and summer months due to the insulation addition and the natural ventilation techniques respectively.

The replacement of the windows might have a limited impact for the building overall (due to the limited percentage of such surfaces) however for the thermal zones in the perimeter of the façade, the impact is significantly higher.
